Debris/Ice/TPS Assessment and Integrated Photographic Analysis for Shuttle Mission STS-58

January 1994

Gregory N. Katnik
NASA/Kennedy Space Center

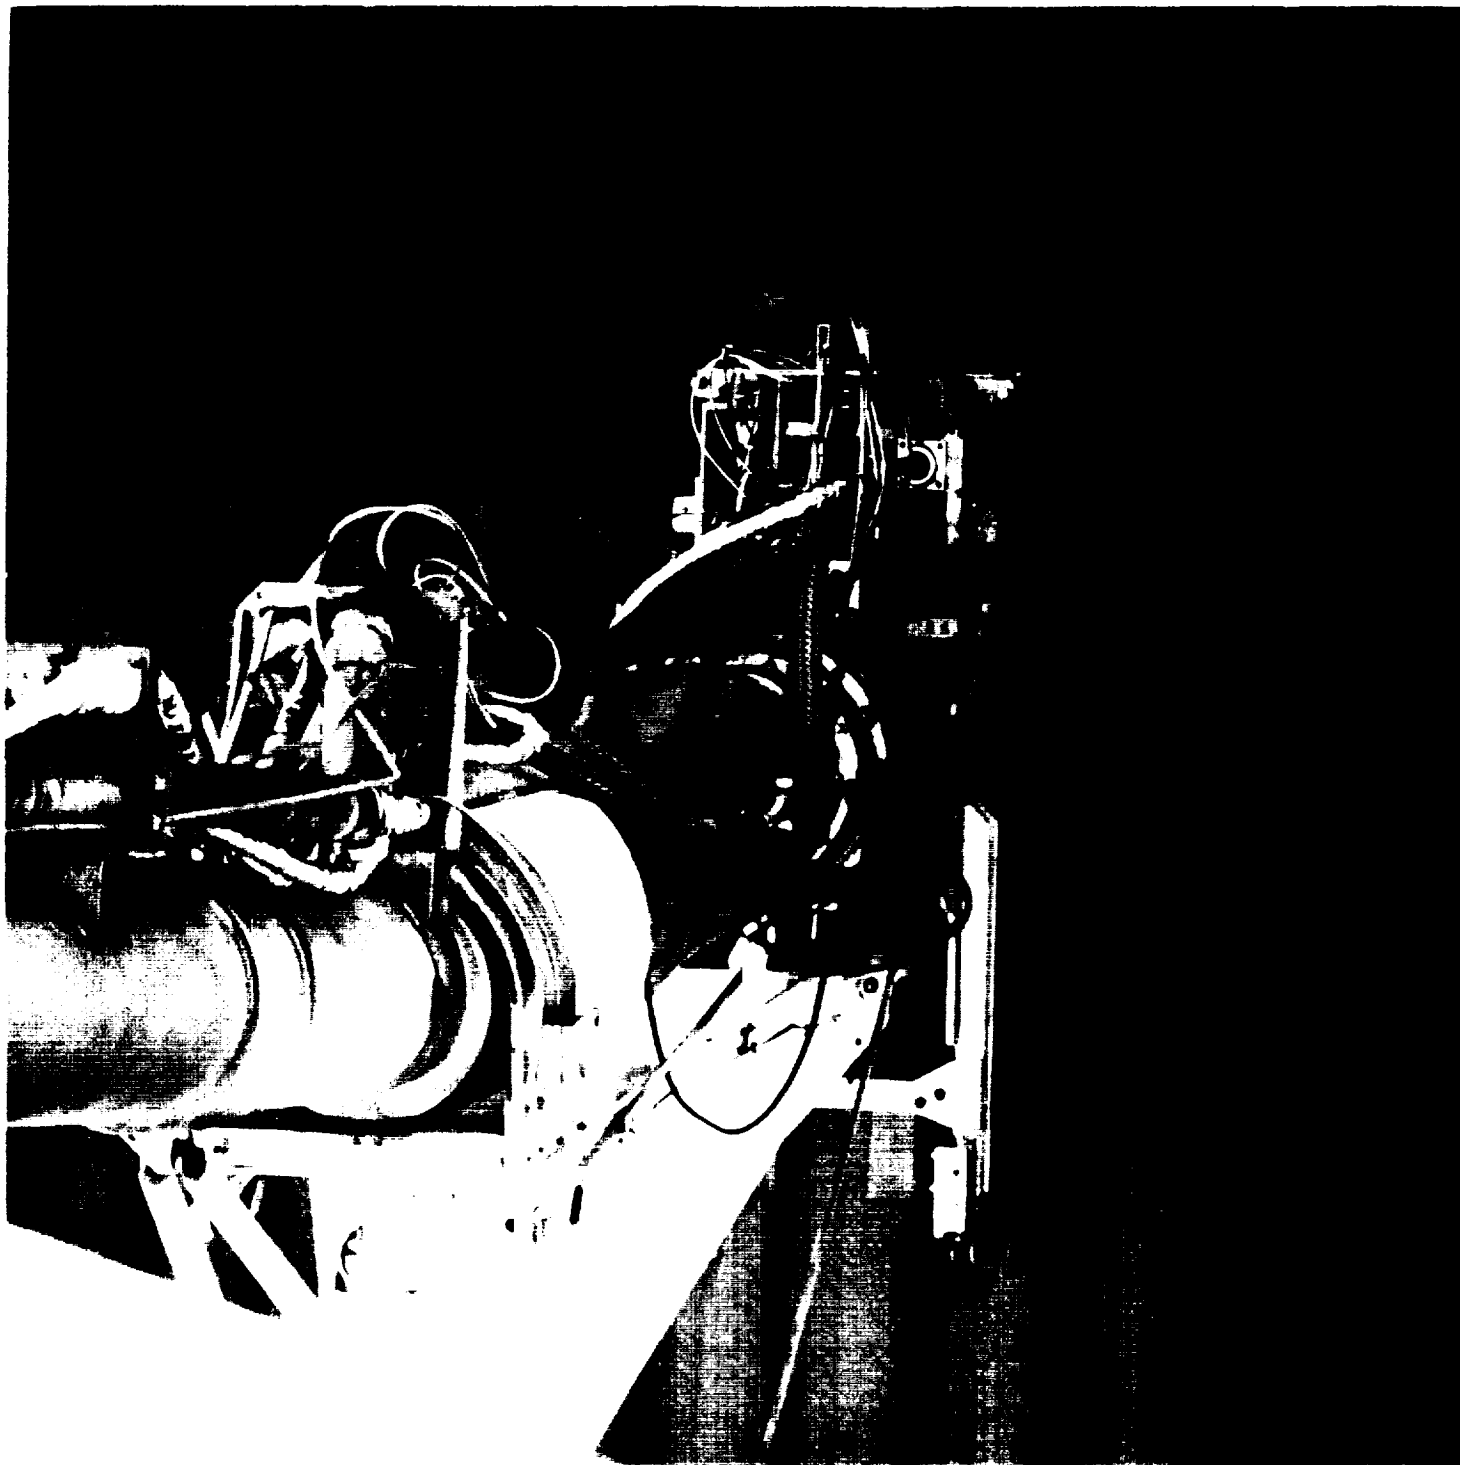
Pre-launch configuration of ET intertank and GUCP

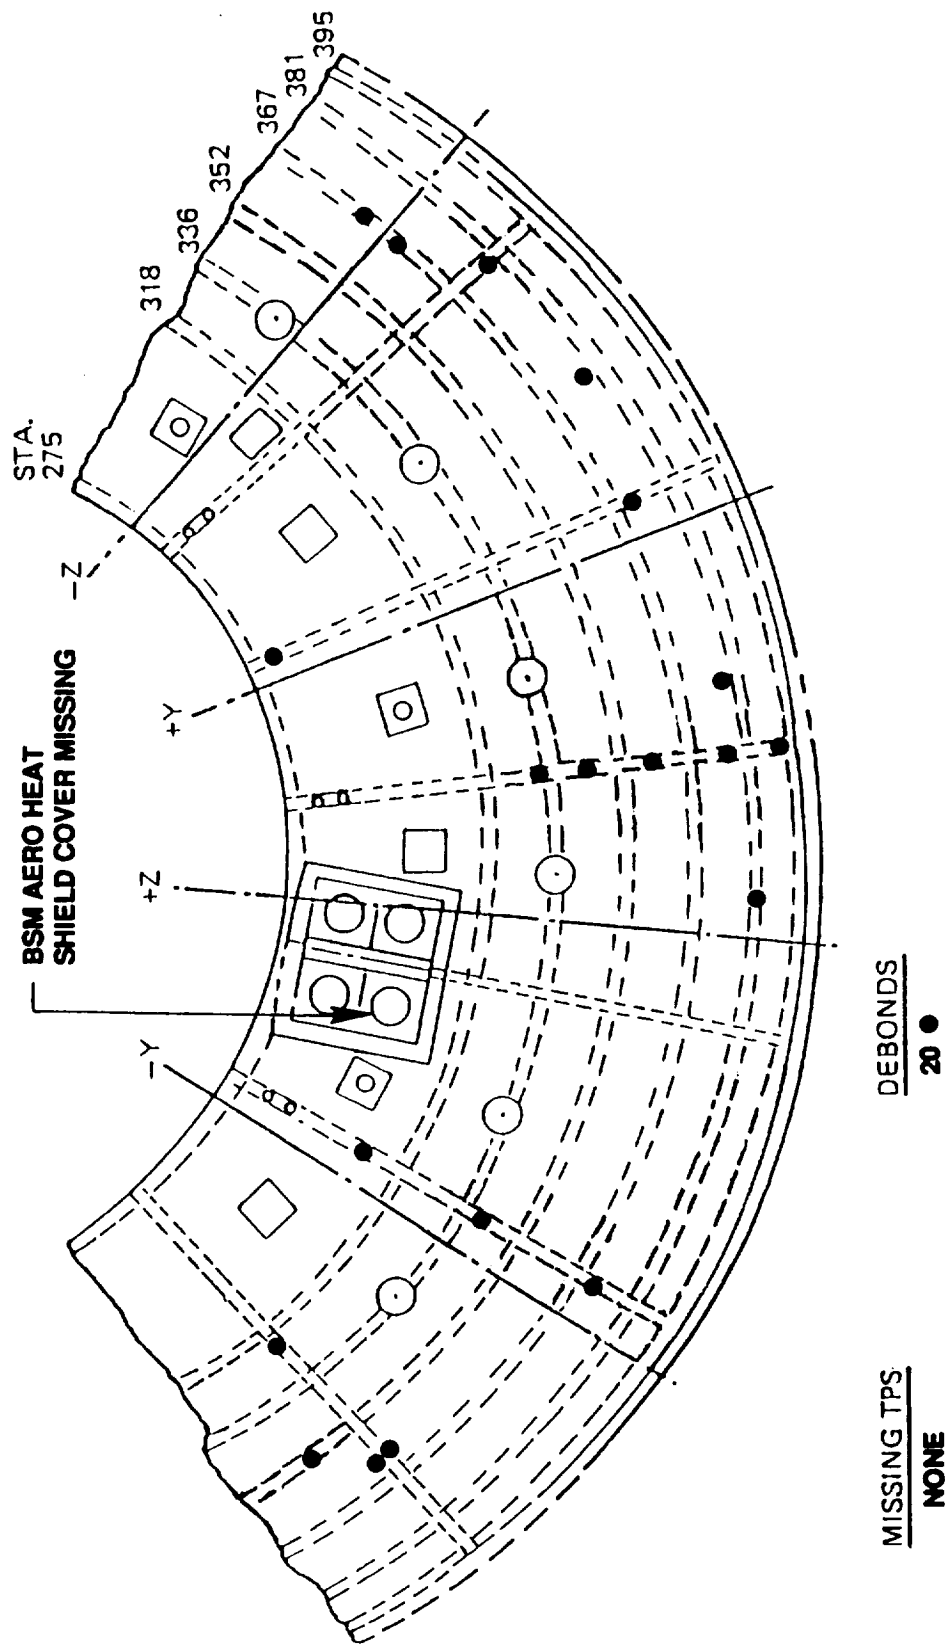
FIGURE 10. RIGHT SRB FRUSTUM

The RH frustum was missing no TPS, but had 20 MSA-2 debonds over fasteners. Minor blistering of the Hypalon paint occurred in localized areas.

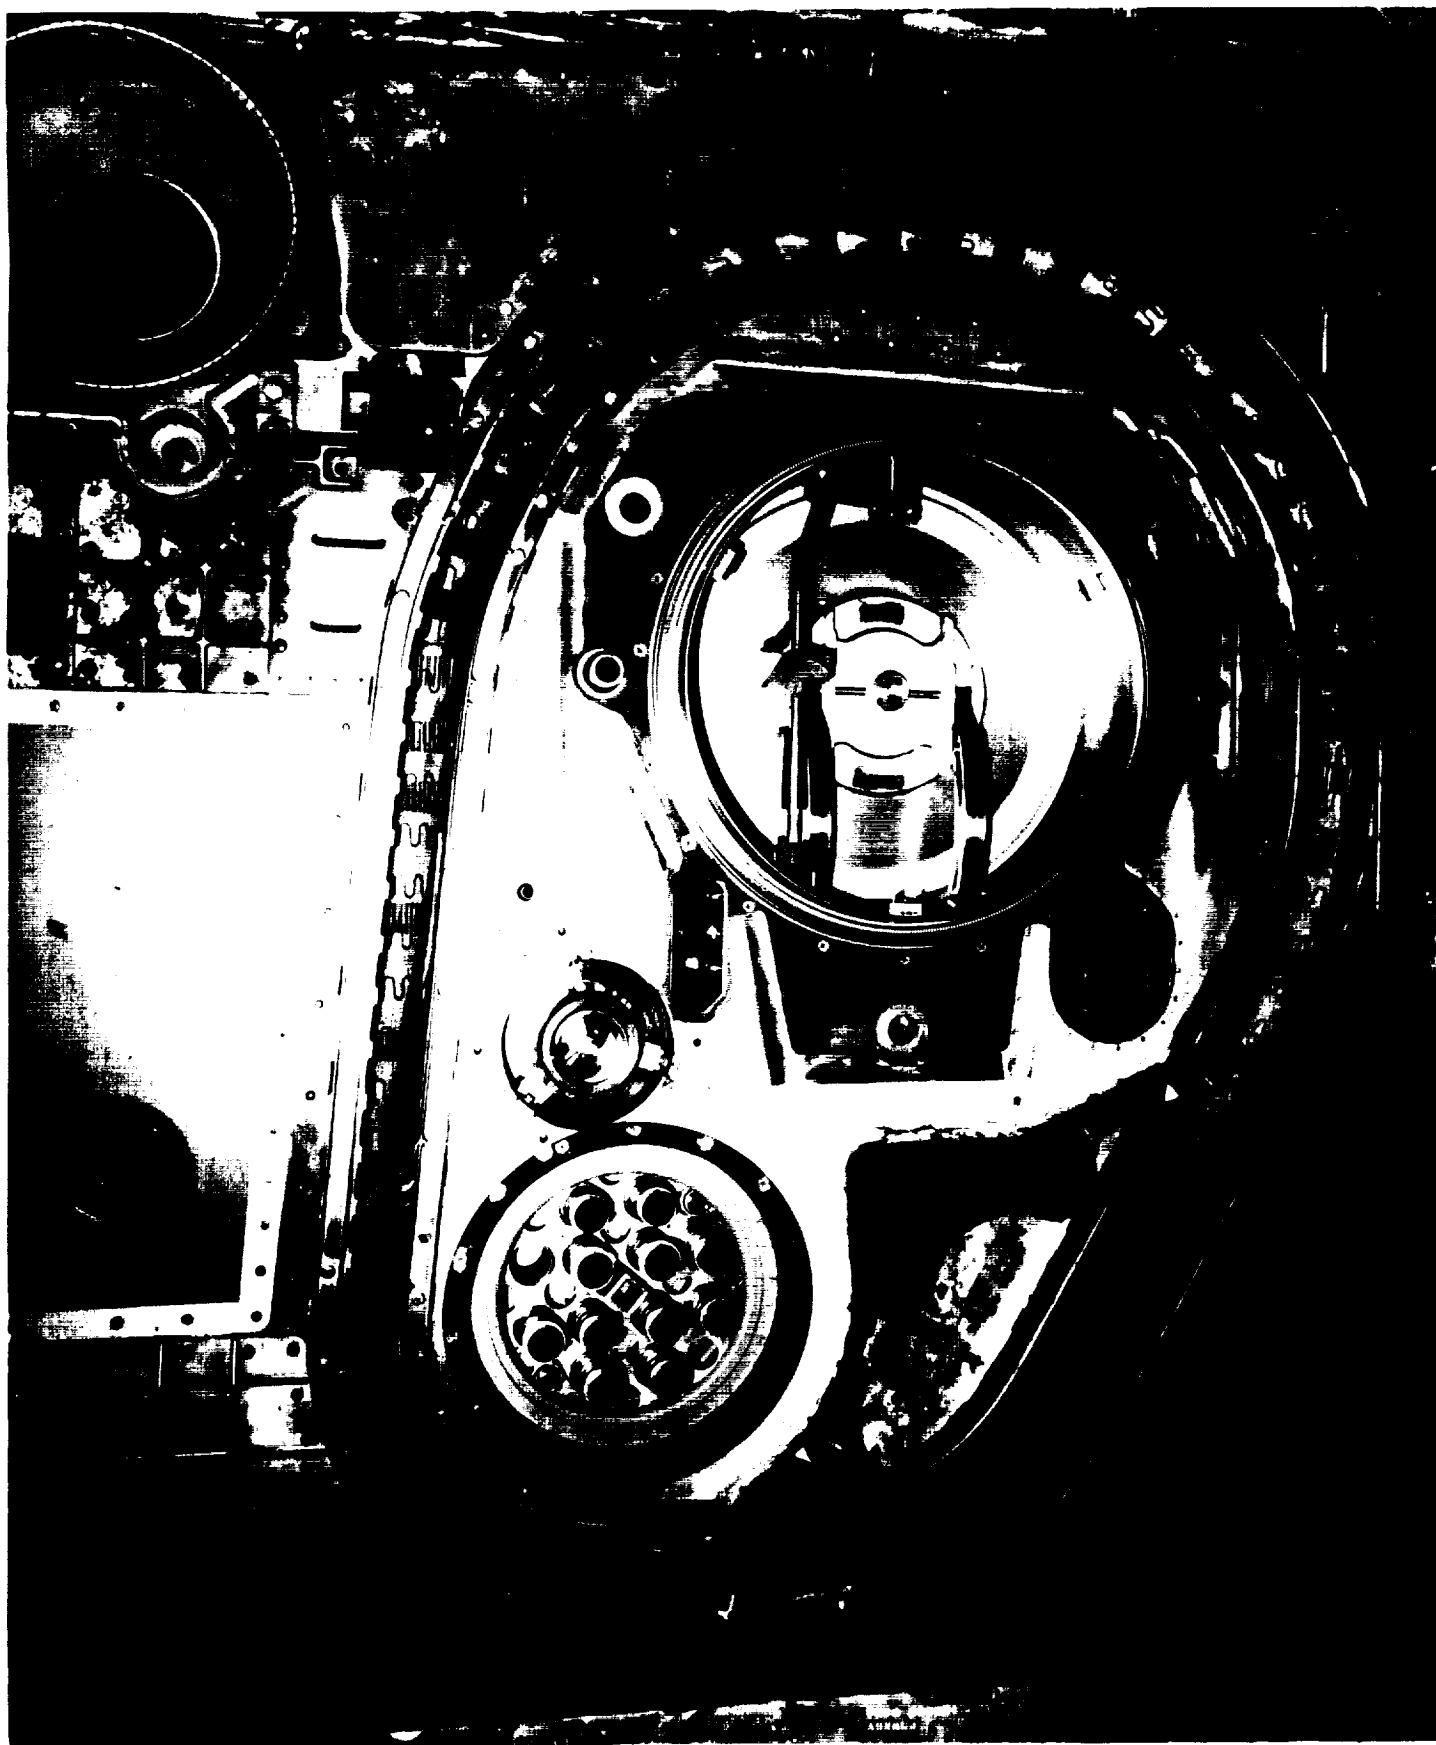
Overall view of the L02 ET/ORB umbilical. All separation ordnance devices functioned properly. No flight hardware was found on the runway below the umbilical when the ET door was opened.

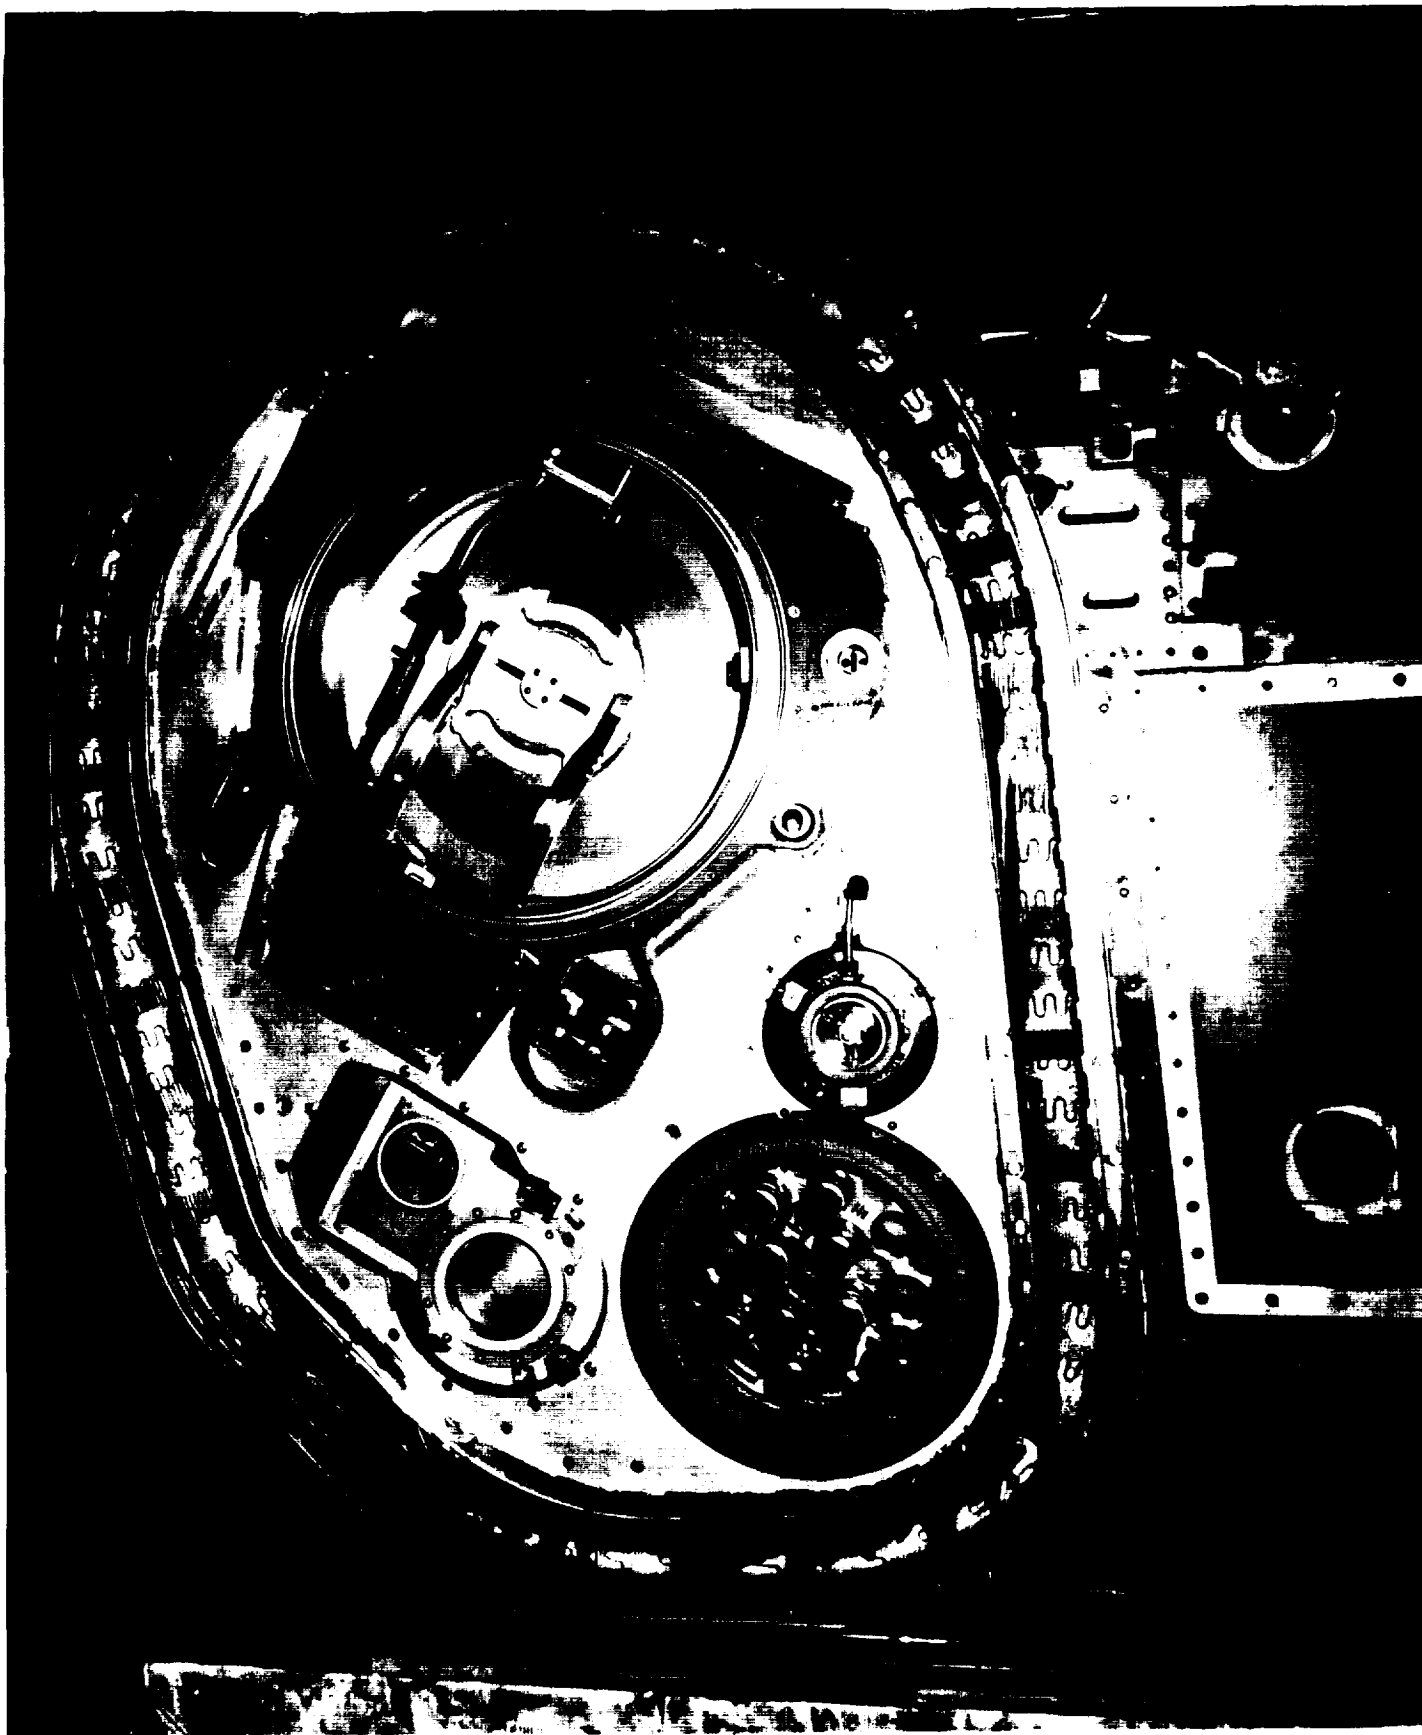
Overall view of the LH2 ET/ORB umbilical. All separation ordnance devices functioned properly. No flight hardware was found on the runway below the umbilical when the ET door was opened.

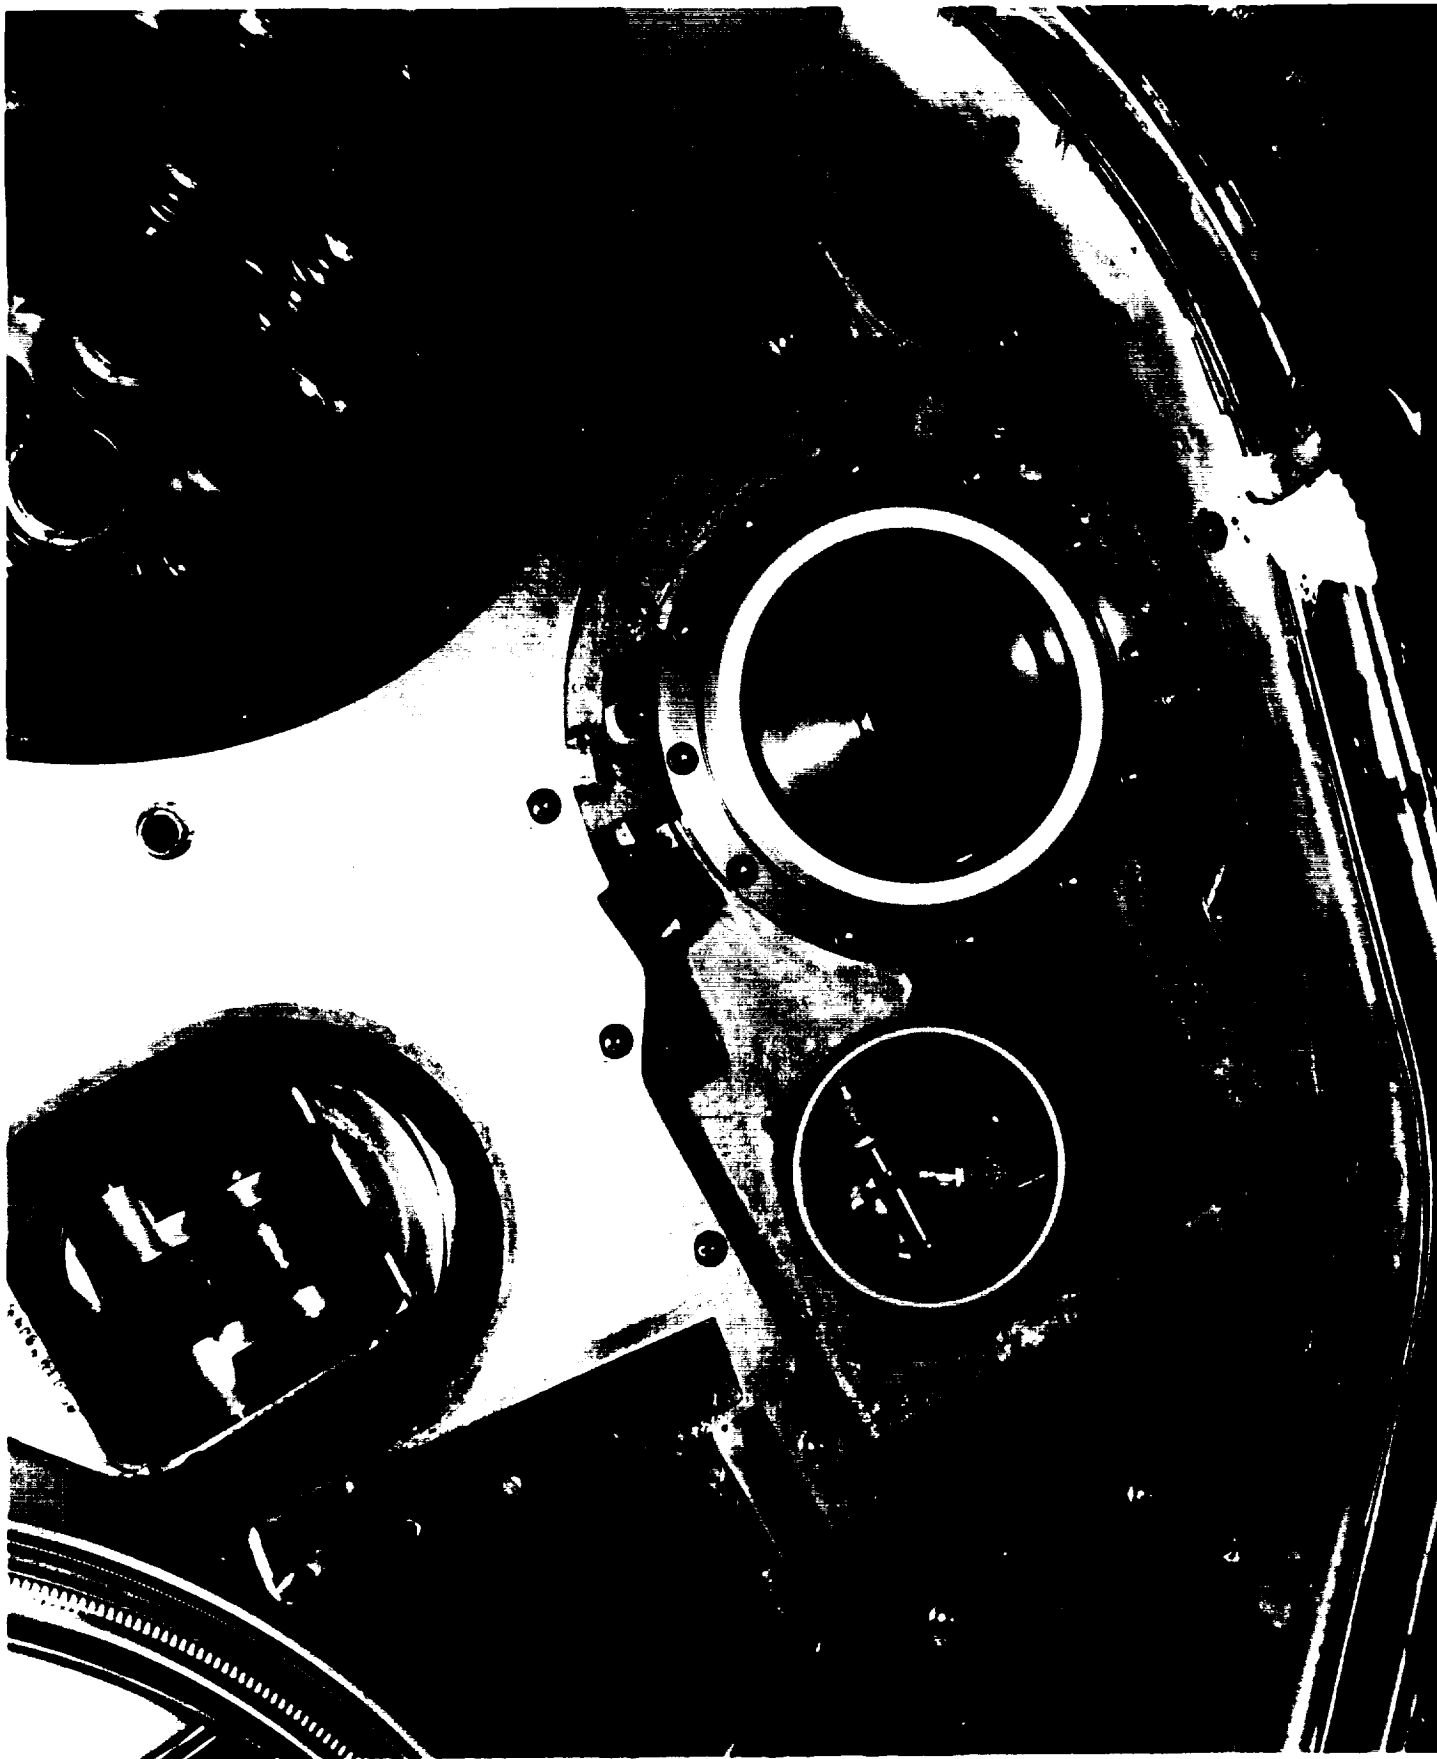
No significant amounts of ET foam or red purge seal adhered to the LH2 ET/ORB umbilical plate near the LH2 4-inch line flapper valve.

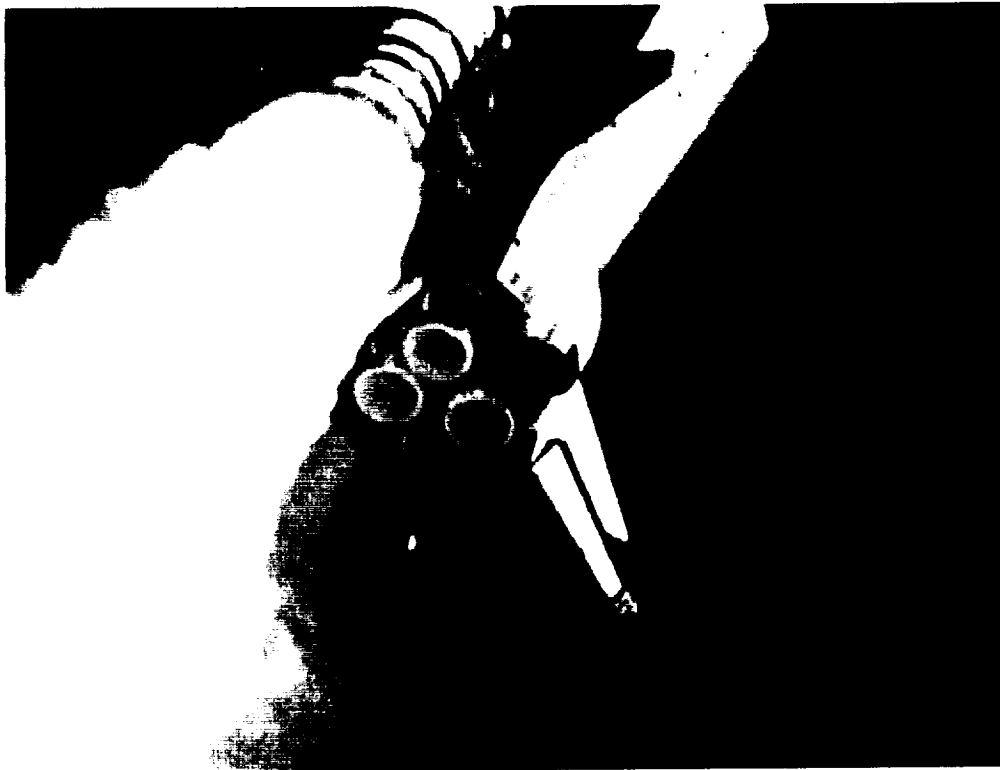
Figure 3.
Debris Falling from Boattail Region

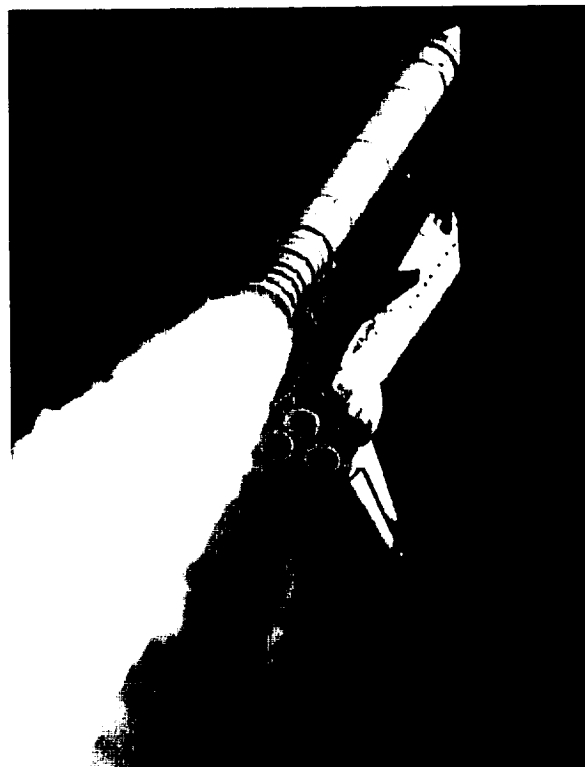
Figure 4.
Large Flash in SSME Plume

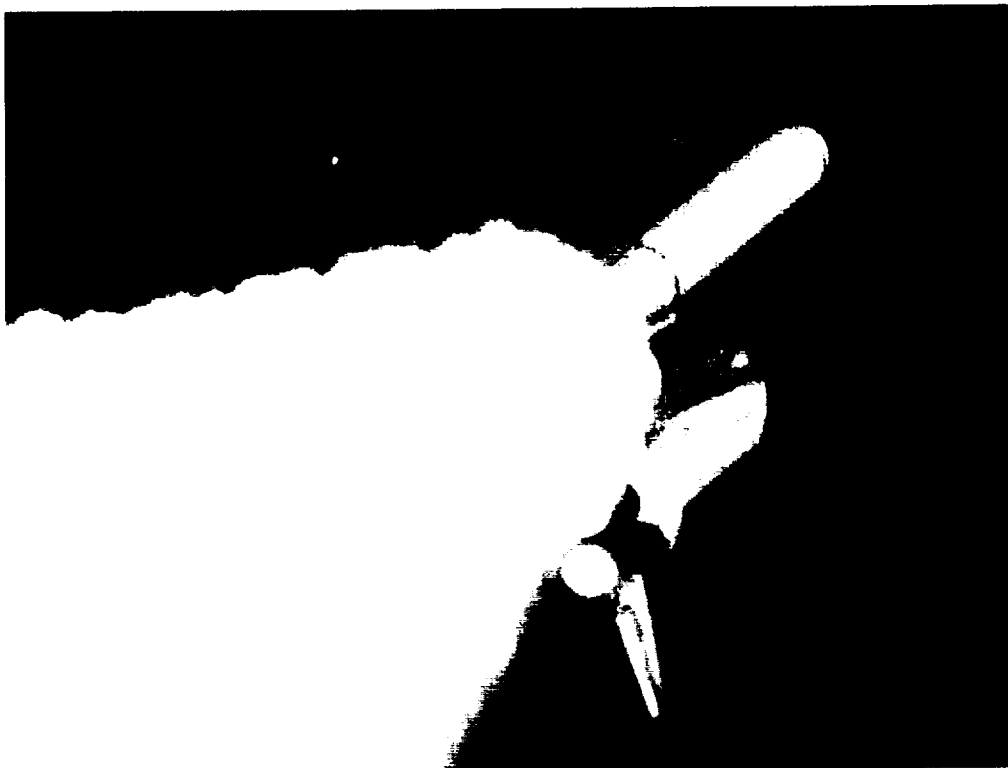
Figure 7 is a film frame from camera E-222 showing solid material exiting from the SRM plume. Twelve pieces of slag were observed exiting the plume between T+64 seconds and T+69 seconds.

Figure 7.
Material Exiting SRM Plume

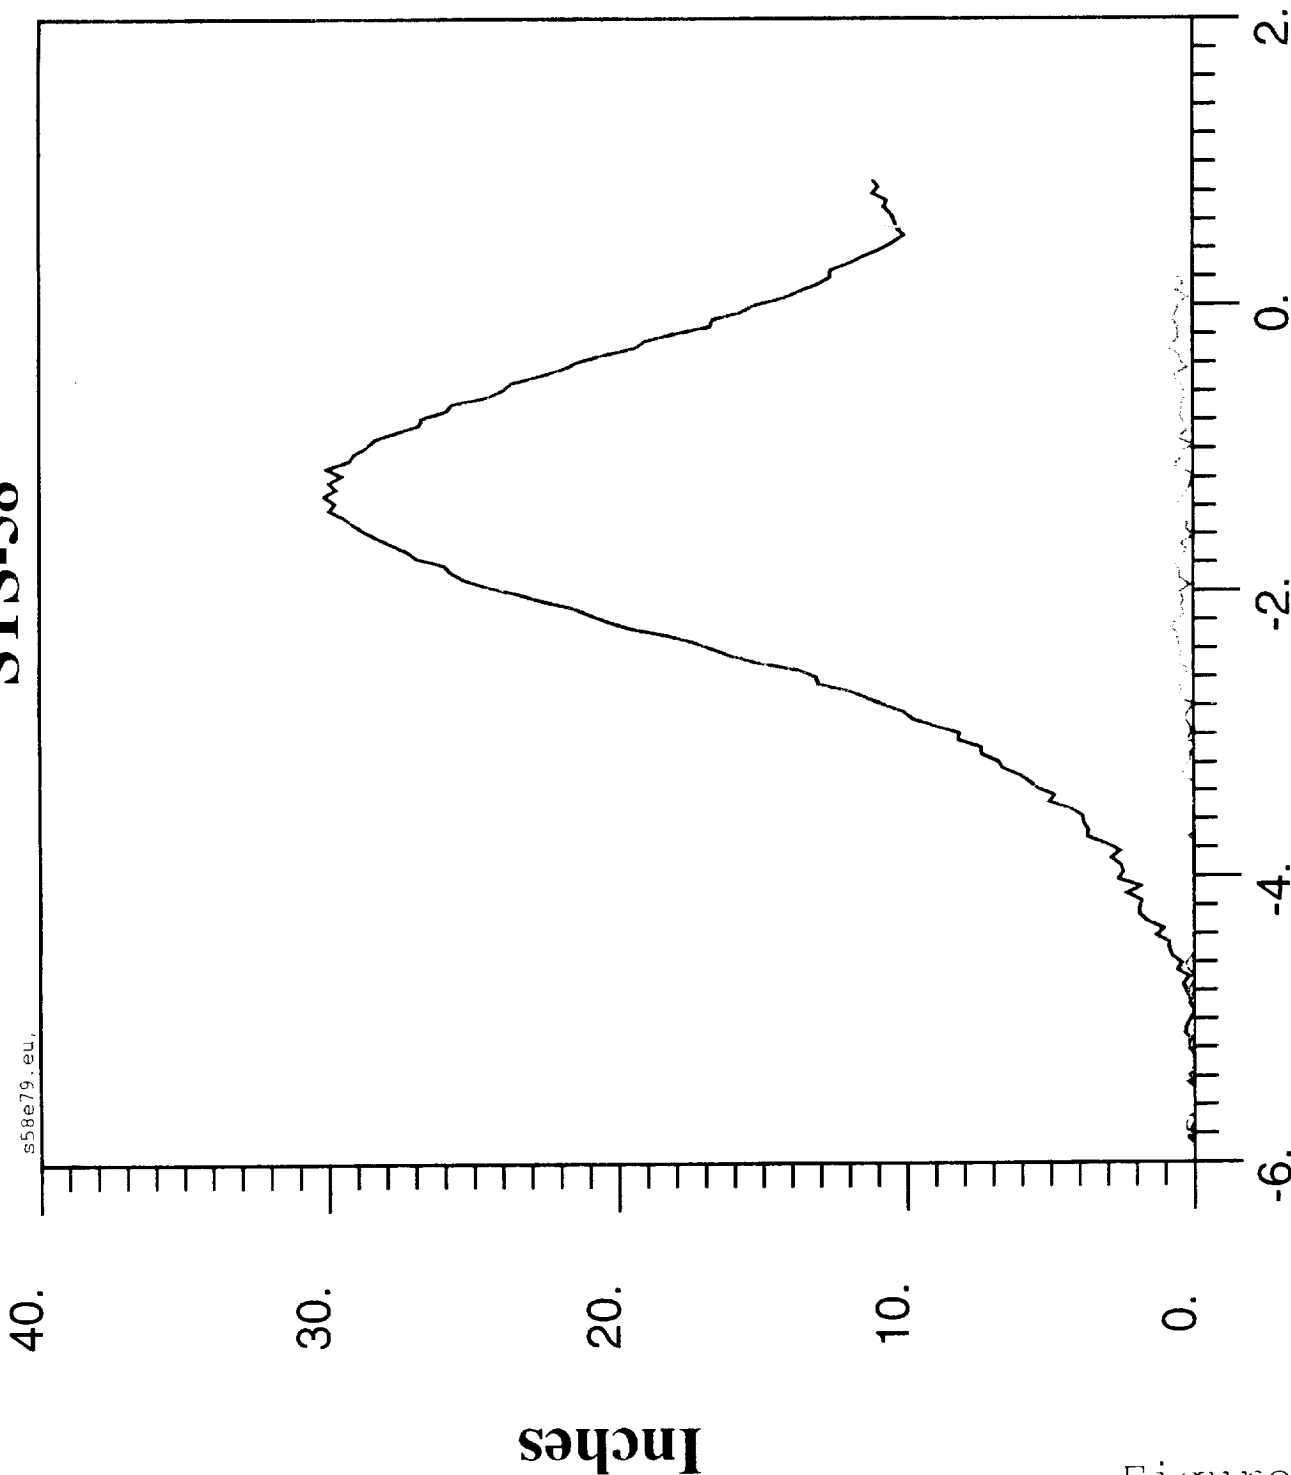
Maximum ET tip deflection for this mission was determined to be approximately 30 inches. Figure 11 is a data plot showing the measured motion of the ET tip in both the horizontal and vertical directions. These data were derived from camera E-79. Camera E-79 exhibited significant image jitter during operation.
